BOLLETTINO TECNICO

N° **139-392**

SUBJECT

MAIN ROTOR (MR) SCISSOR LEVER BEARING P/N 3G6230V00654

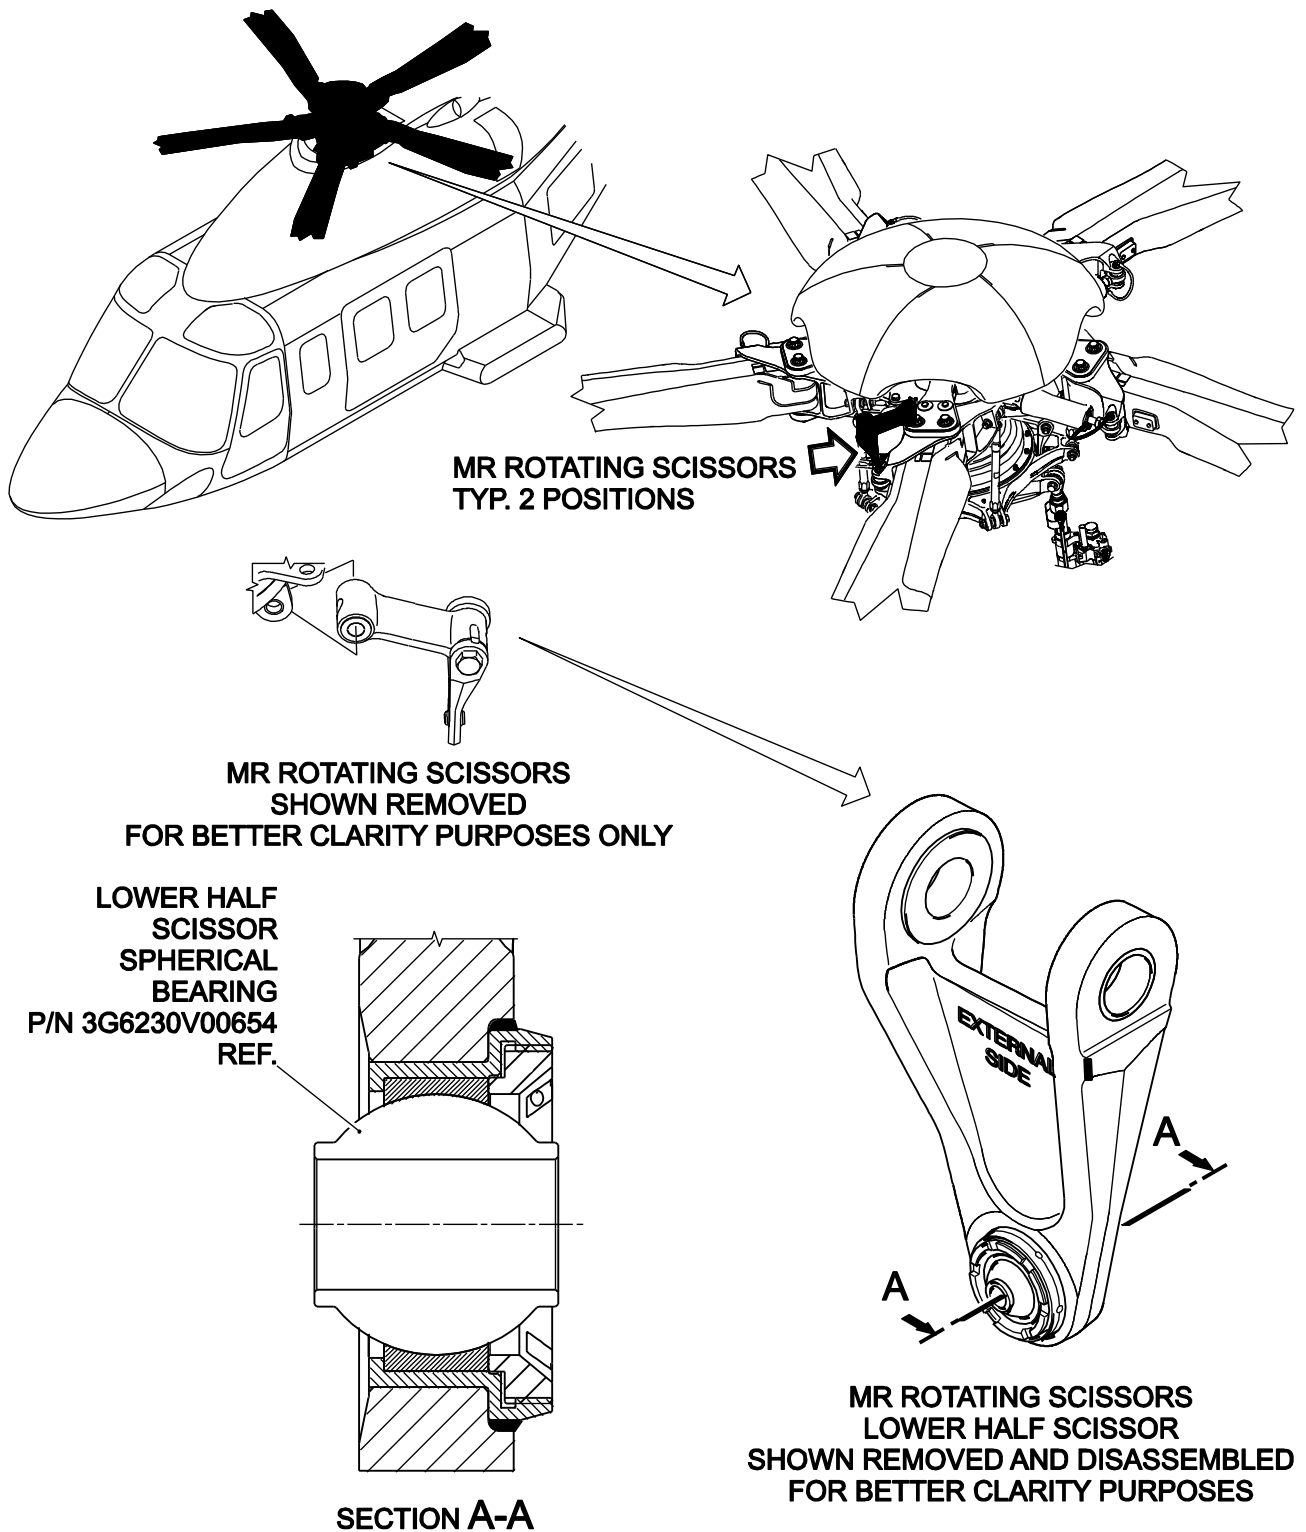
Figure 1

4. With reference to Figure 1, get access to the MR area and perform a general visual inspection of the MR rotating scissors, using a magnifying glass and a hand torch, paying particular attention to the spherical bearings.

5. With reference to Figure 1, perform an operational check for play and wear of the lower half scissors spherical bearing P/N 3G6230V00654 (refer to section A-A), paying particular attention to the bearing staking condition; to do this, manually move the lower half scissor along the axis of the spherical bearing.

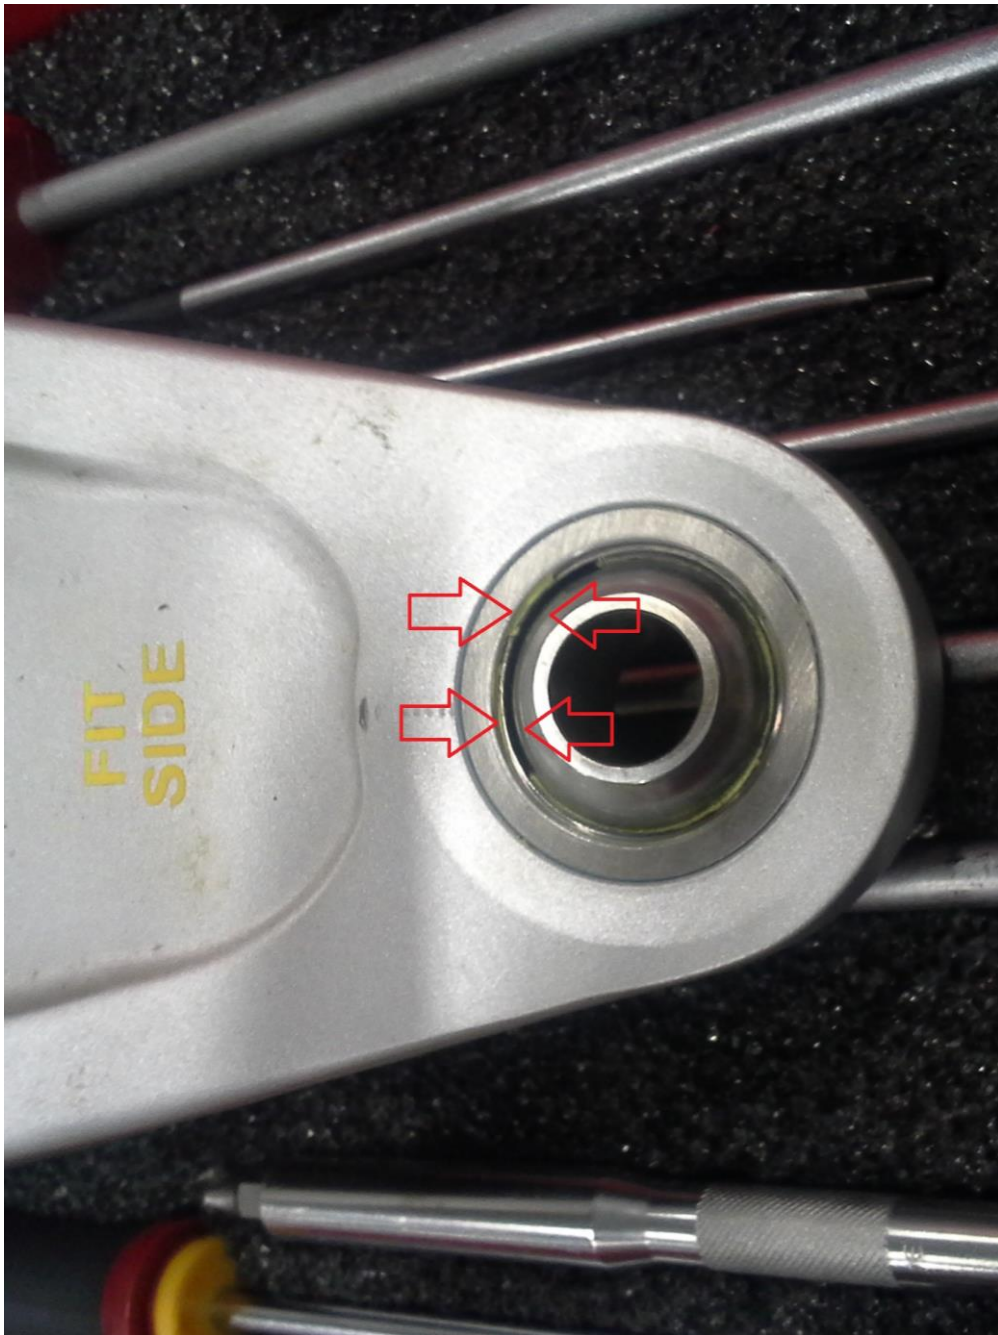
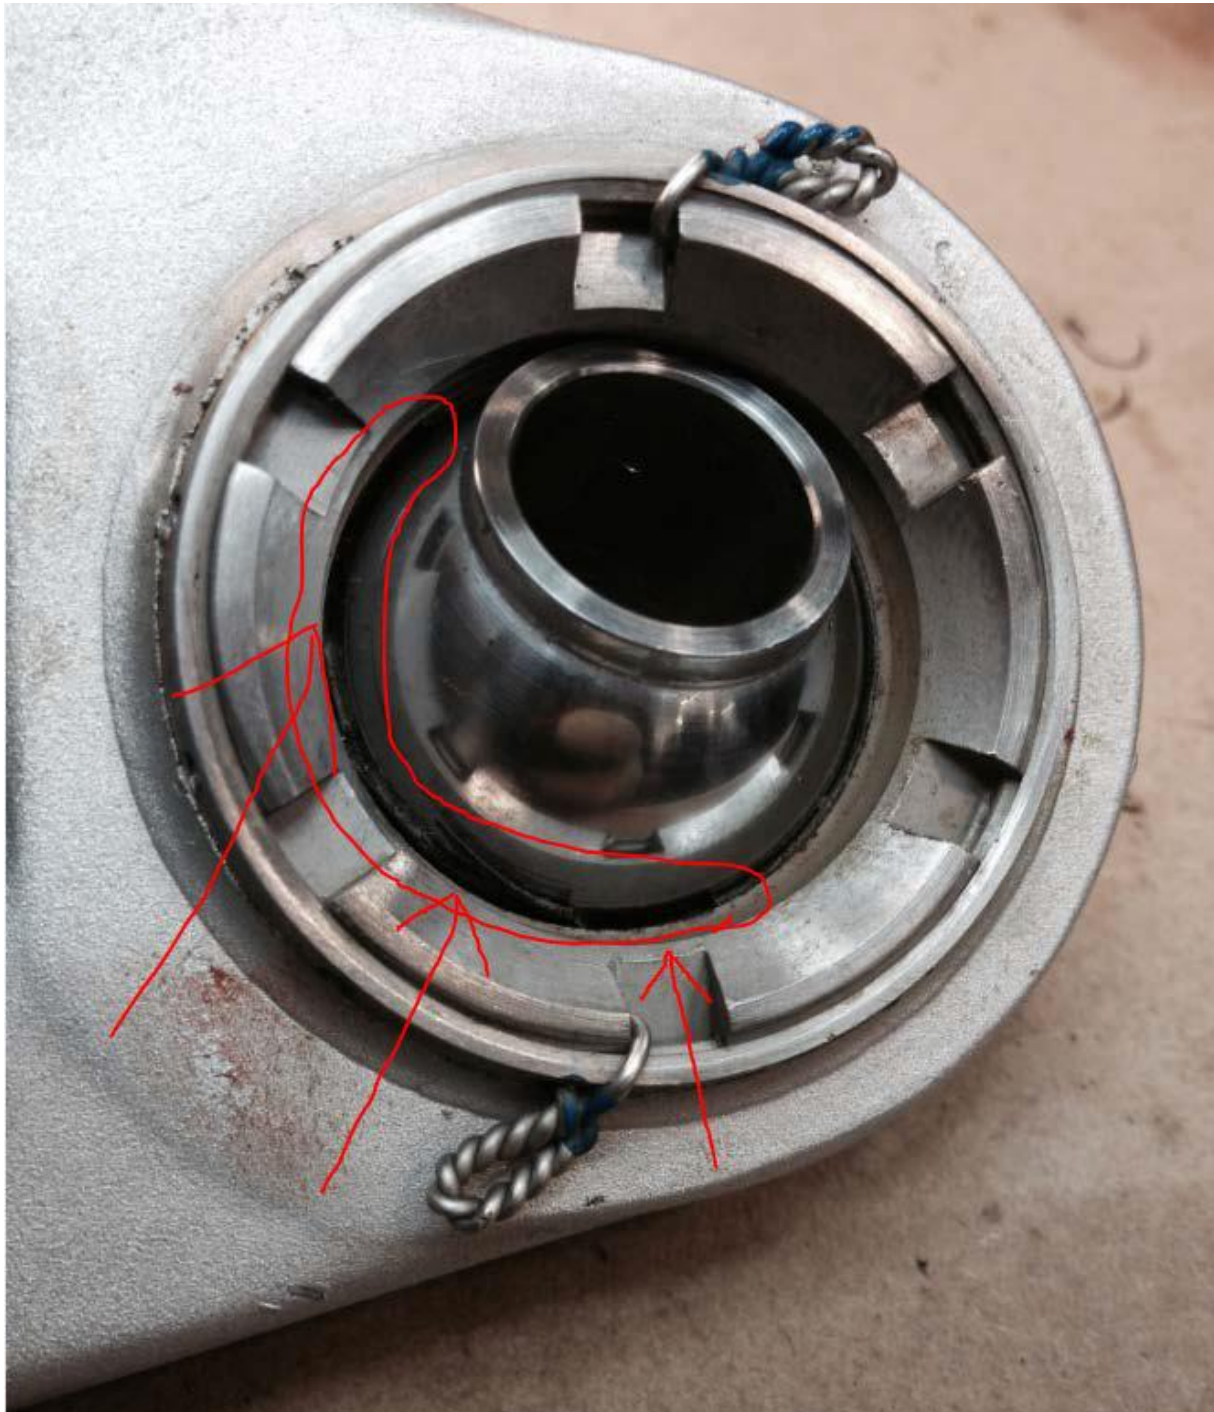
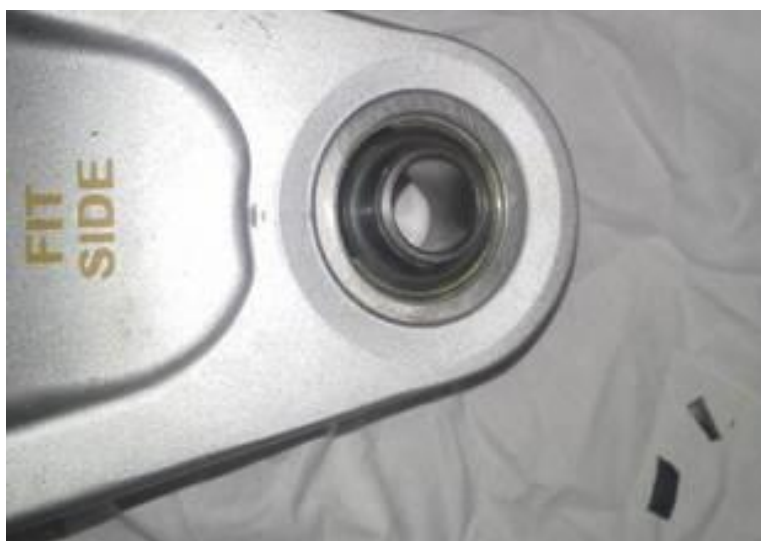
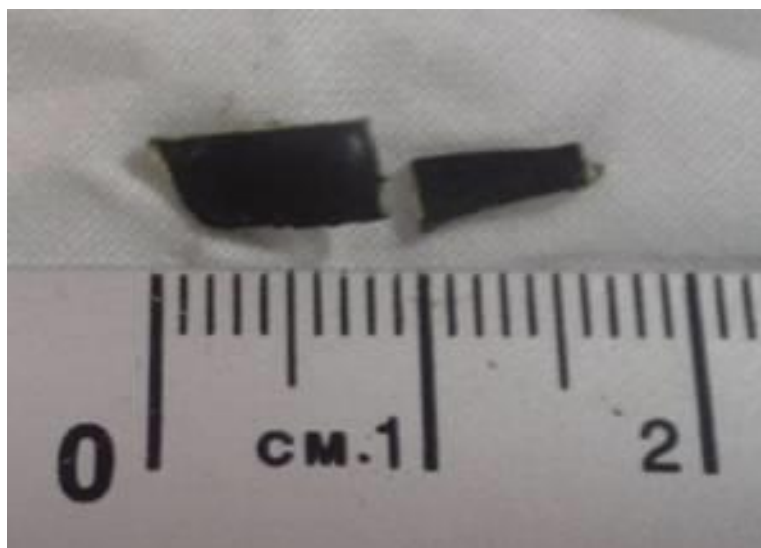
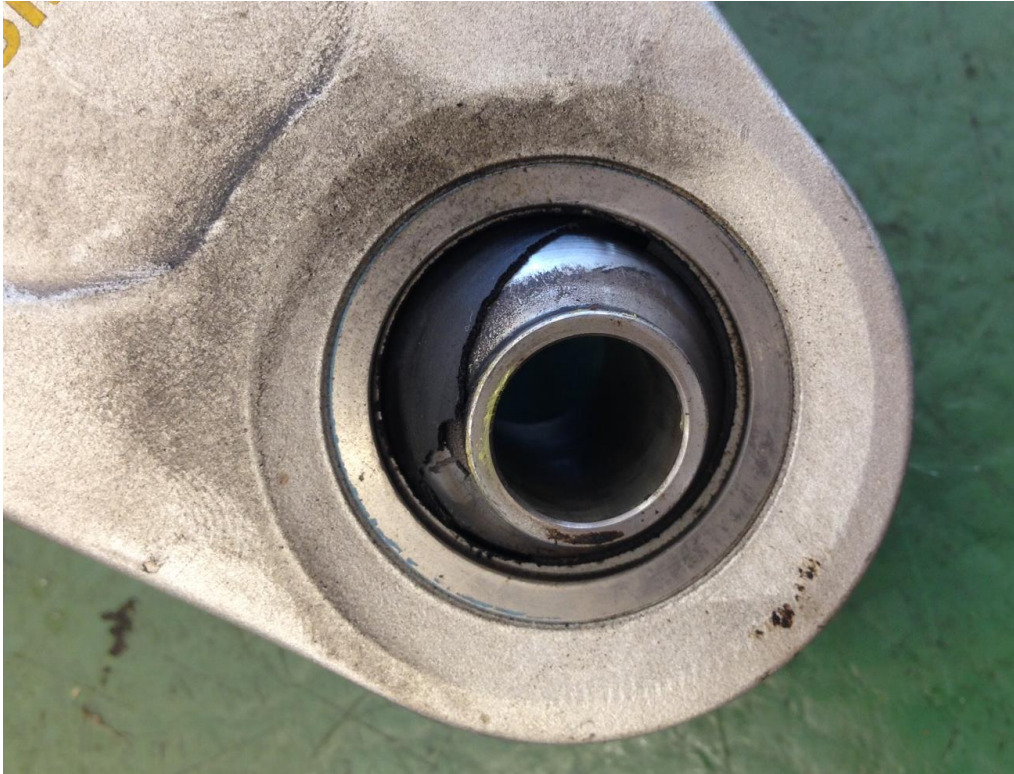
- 4.1.8. Go to step 6.
- 4.2. If you find damage (a typical damage is shown in figures 4 thru 8) on the scissor lever bearing, perform following steps:
 - 4.2.1. Replace it with a new one P/N 3G6230V00655. Refer to AMP, see DM n° 39-C-62-31-02-00A-921A-B.

5.2.2.1. Replace the scissor lever bearing with a new one P/N 3G6230V00655. Refer to AMP, see DM n° 39-C-62-31-02-00A-921A-B.

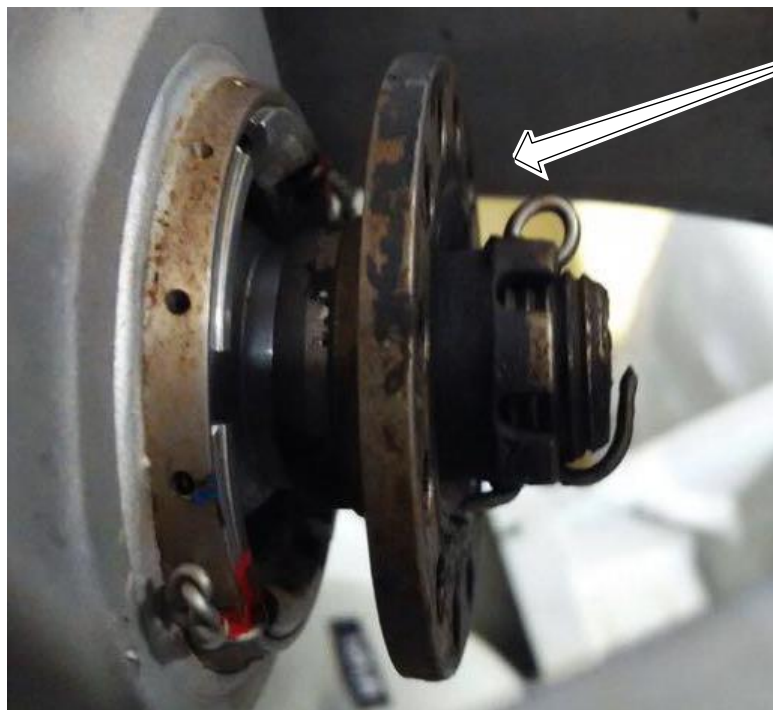
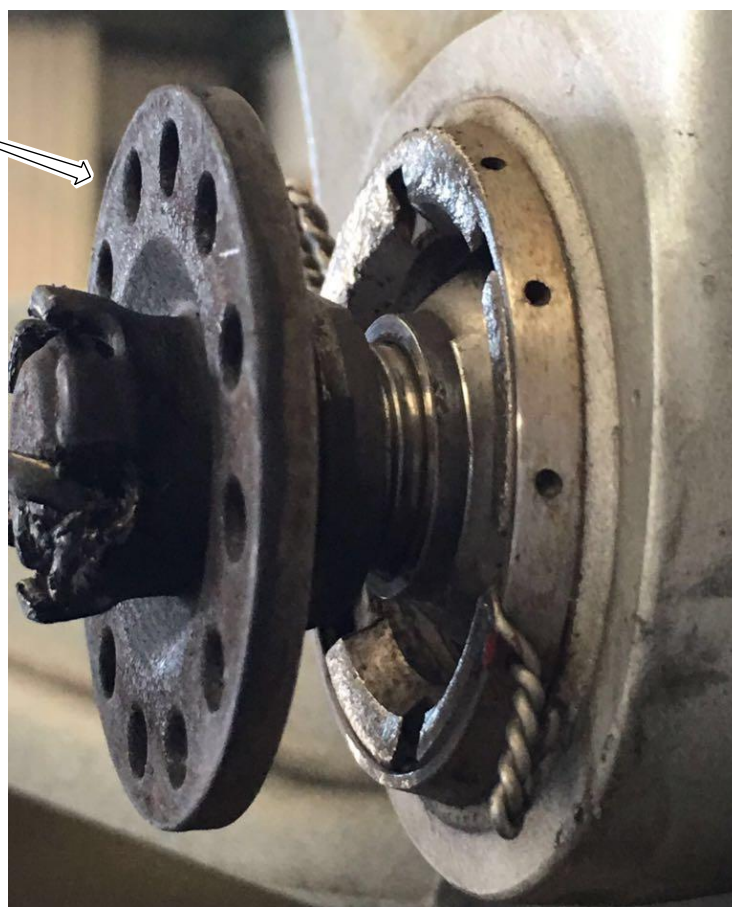
Figure 9

- 4.1. If the scissor lever bearing is free to move out of its seat (an example of effects of scissor lever bearing dislodging is shown in figure 9), perform the following steps:

**LOWER HALF SCISSOR
3G6230A06851 SPECIAL NUT
CORRECT INSTALLATION**

**3G6230A06851 SPECIAL NUT
POSITION
AFTER
SCISSOR LEVER BEARING
DISLODGING**

- 4.1.1. Remove the rotating scissors. Refer to AMP, see DM n° 39-C-62-31-02-00A-520A-A.
 - 4.1.2. Remove the scissors attachment flange. Refer to AMP, see DM n° 39-A-62-22-15-00A-520A-A.

- 4.1.3. Discard all the rotating scissors attaching hardware you have removed at steps 4.1.1 and 4.1.2. Use new hardware at following steps 4.1.4 and 4.1.5.

- 4.1.4. Install a new scissors attachment flange P/N 3G6220A00633. Refer to AMP, see DM n° 39-A-62-22-15-00A-720A-A.
 - 4.1.5. Install new rotating scissors fitting the new scissor lever bearing P/N 3G6230V00655. Refer to AMP, see DM n° 39-C-62-31-02-00A-720A-A.
